City of St. Helena “RUTHERFORD 12” WATER PIPELINE REHABILITATION”

PIPE BURSTING STEEL PIPE

Collins Orton
2/17/2011

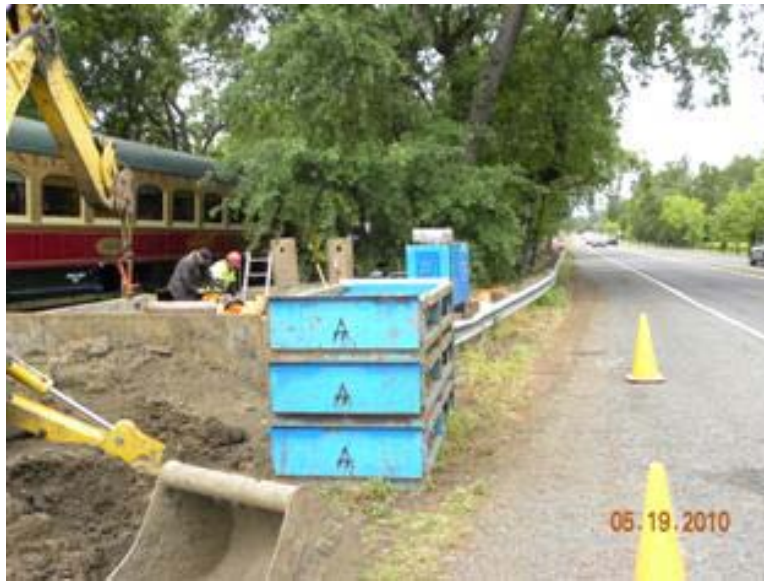
Figure 1. Tight conditions. Note: A State highway on one side of the jobsite and a rail line on the other.

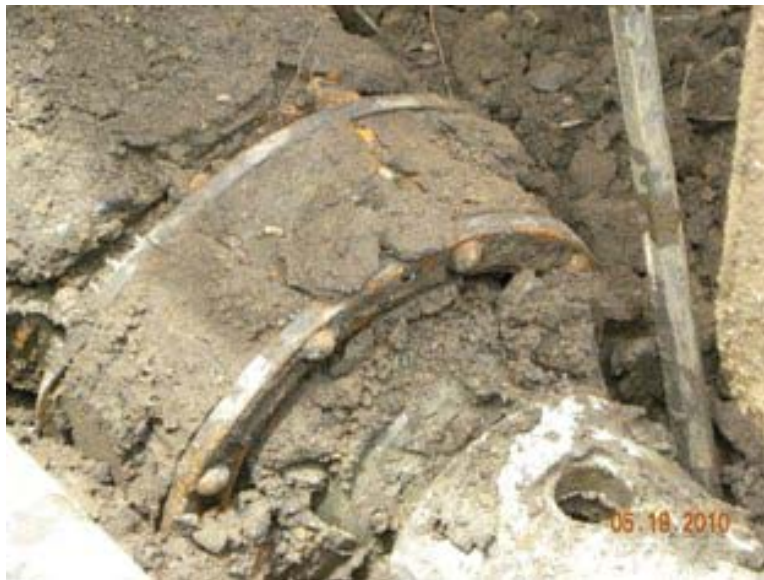
With the Dresser couplings at each joint the pipe splitting system had to split both the steel pipe and the Dresser couplings. See Figure 2.

Figure 2. Style 38 Dresser Coupling.

The couplings added several inches to the diameter of the pipe. Team Ghilotti contacted trenchless equipment manufacturer TT Technologies, Inc., Aurora, IL. to brainstorm on a different method to reliably split the pipe and couplings, which the other bursting system failed to do. TT Technologies was asked to determine if the pipe and couplings could, in fact, be split reliably. Between Team Ghilotti and TT Technologies it was decided to excavate, remove, and ship back to the factory a 10-foot long section of welded steel pipe (WSP) containing a Dresser coupling in the middle for above ground testing. The above ground testing ensured all parties could witness the results and how the tests were carried out. Within two hours of the decision to ship a piece of pipe it was on a plane to Aurora, IL. The following images demonstrate the way the pipe and couplings were split. A Grundoburst 1250 G

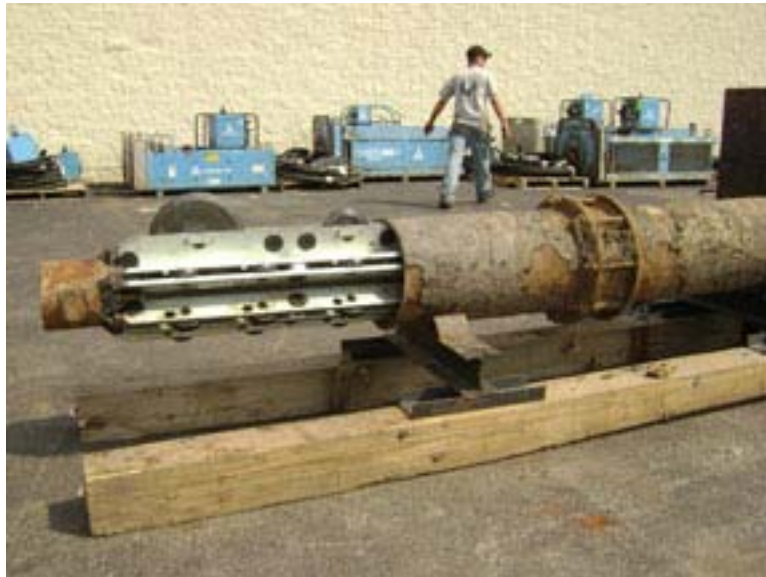
Figure 3. Above ground test, launching the cutter head.

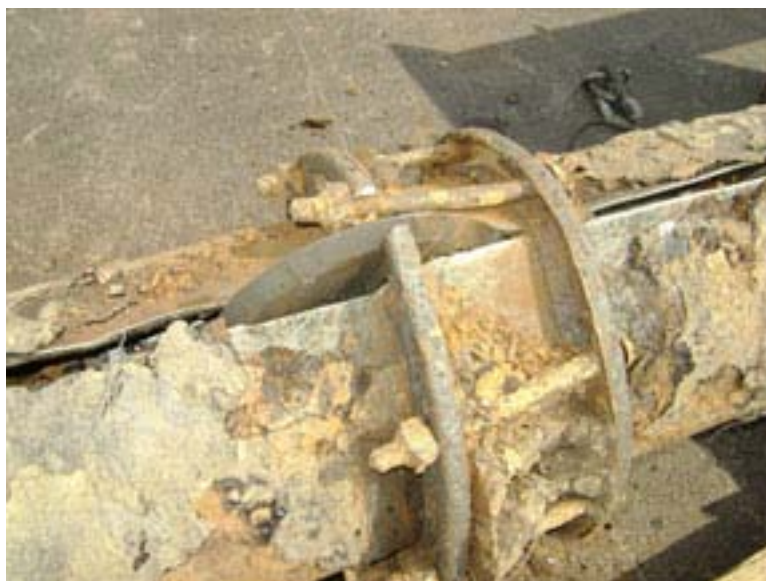
Figure 4. Above ground test, splitting the Dresser Coupling.

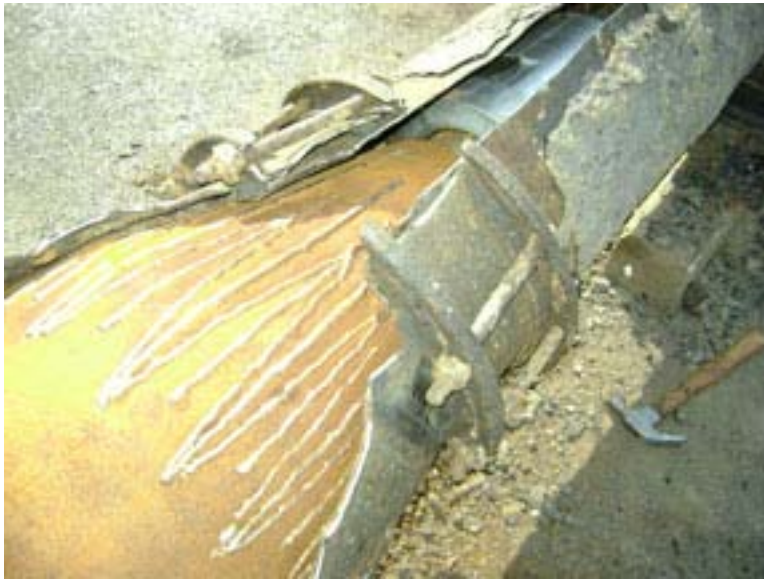
Figure 5. Above ground test, coupling successfully split.

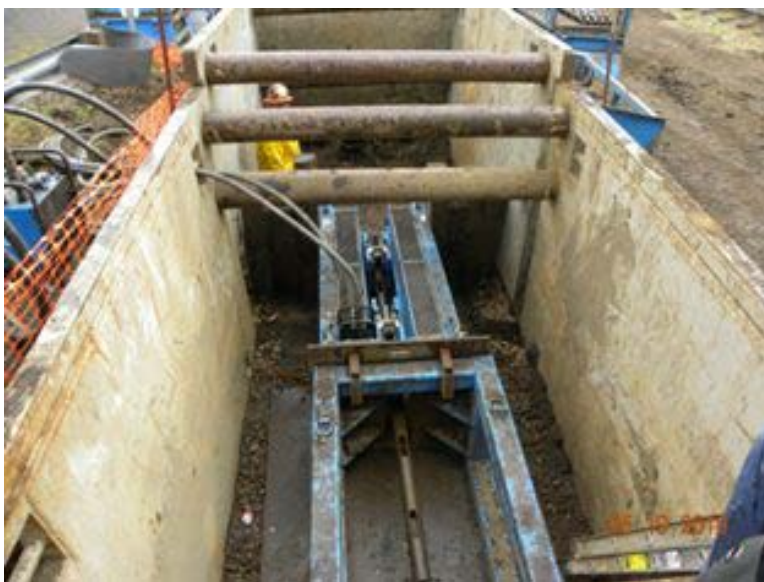
Figure 6. Static bursting unit.

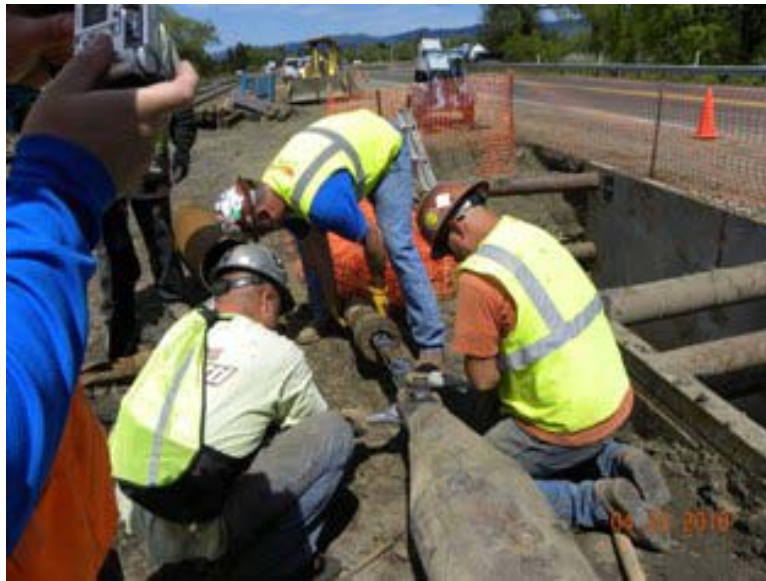
Figure 7. Connecting the bursting head and pipe string.

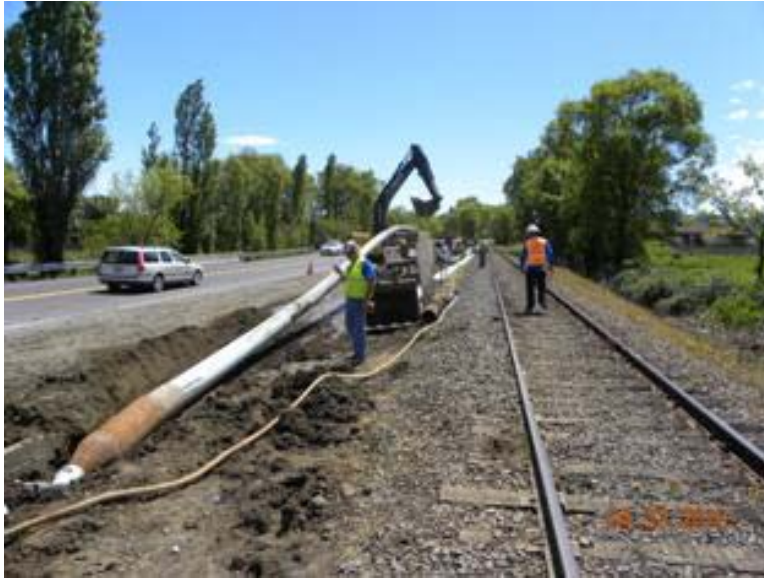
Figure 8. Bursting run launch.
