The Northern California Pipe User's Group
18th Annual Sharing Technologies Seminar

CITY OF SANTA CLARA TRIMBLE ROAD TRUNK SANITARY SEWER CONDITION ASSESSMENT

Brian Avon¹, Tim Taylor¹, and Falguni Amin²

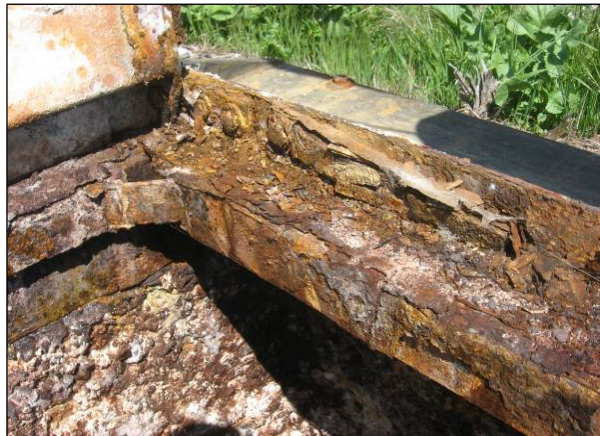
Many of the manholes along the Trimble Road alignment have suffered minor to severe corrosion. Six of the seven manholes at the northeast end of the pipeline (just prior to discharging into the San Jose interceptor at Zanker Road) are graded VANDA™ Level 4. Based on this rating, rehabilitation of these structures is no longer feasible or recommended. Replacement is the only option. Of the 90 pH samples taken, 77 had a pH below 6.5, indicating the concrete in the majority of these manholes is experiencing moderate to severe corrosion. During the manhole inspection sediment deposits were noted. The deposits were found, primarily in the manhole channels, but minor deposits were also found in the influent or effluent pipe. Most of this debris appears to be from concrete mortar and aggregate that has fallen from the manhole chimney and barrel surfaces into the channel. Figures 2 and 3 show some of the recurring issues that were witnessed during the inspection.

Figure 2. Corroded Frame of JB 68-9

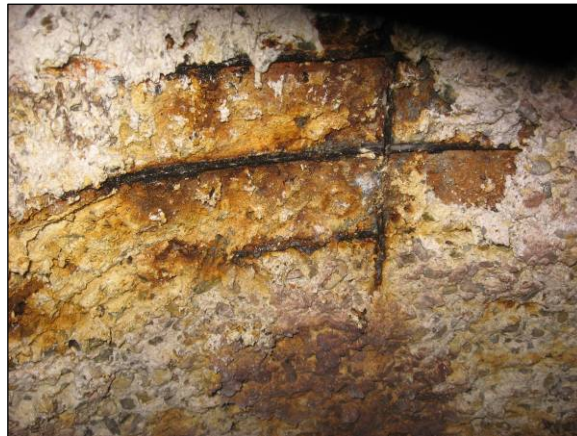
Figure 3. Exposed corroded reinforcing steel MH 79-13

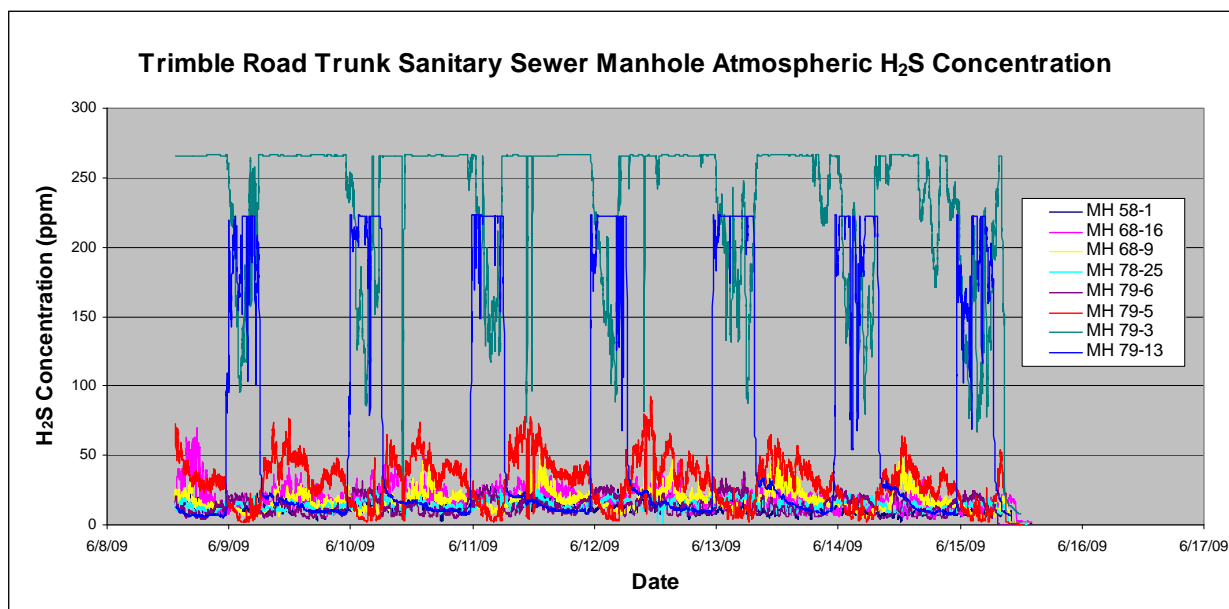
Grab samples taken at the 8 locations chosen for H₂S monitoring revealed that the dissolved sulfides in the wastewater ranged from 0.3 to 2.1 parts per million (ppm). Average manhole temperatures during the sampling ranged from 76 degrees F to 82 degrees F. A graphical representation of the H₂S concentrations by the deployed OdaLog Gas Loggers is shown in Figure 4. The data shows a significant increase in H₂S concentration at the two manholes measured closest to the interceptor. It was also found that during normal daily operation, MH 79-3 saw levels of H₂S that were higher than the OdaLog data collector could record. During times of low flow, the concentration of H₂S at MH 79-3 would reduce to normal levels, while the level in the manhole between 79-3 and the interceptor (MH 79-13) would spike.

Figure 4. H₂S Concentrations In Select Manholes

Utilizing the data collected during the field inspections and the data provided by the City, a clear picture of how the system operates under normal daily operation became more clear. It was derived that the cause of the high concentration of corrosion witnessed by the City O&M staff was due to the pipe running full approximately 80% of the time on a daily basis. With the pipe full and the downstream manhole surcharged, it's apparent that there is no air gap for the H₂S gas to flow downstream. As a result, all the gas accumulates in MH 79-3, causing a lethal concentration of H₂S. At night, when the flows reduce, the level of the water in the pipe was able to subside enough to allow for the H₂S to escape downstream. The escaping H₂S gas explains why the downstream manhole MH 79-13 experiences such high concentrations when MH 79-3's surcharging is alleviated.
