The Northern California Pipe User's Group  
19th Annual Sharing Technologies Seminar

Berkeley, CA  
February 17, 2011

## Video and Sonar Assessment of the Coronado Transbay Sewer Force Main Under San Diego Bay

Elmer Alex<sup>1</sup>, PE with Contributions from Marc Solomon<sup>2</sup>, PE and Ed Walton<sup>3</sup>, PE

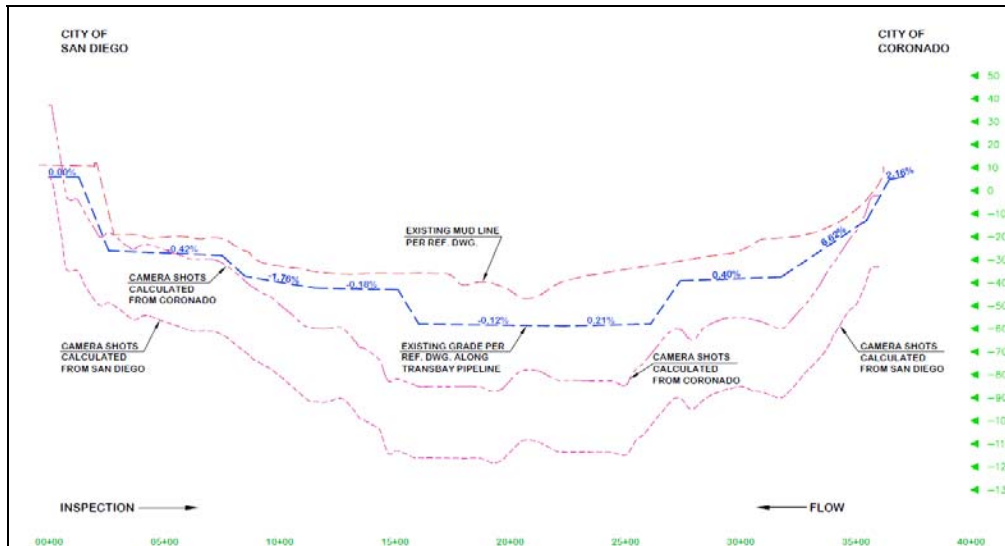
Figure 2: Profile of Original Force Main using As-Built Data and Camera Data

Instantaneous slope values from the inclinometer were used to plot the approximate profile of the pipeline. The plot of the profile is shown in Figure 2. Winzler & Kelly plotted the data starting from the outfall manhole in the City of San Diego to Coronado and vice versa. Because the slope values were instantaneous values and not continuous, the profiles shown in Figure 2 should not be deemed exact representations of the actual profile. In both cases, the profile generated from the inclinometer data shows the inspection ending at an elevation offset by 30 feet. This is likely due to the constantly changing slope and high level of debris during the first 130 ft of inspection that can affect the crawler’s ability to obtain accurate inclinometer readings. The plotted profiles should be represented as a guide of the general profile that the pipeline has. The plotted profiles generally follow the as-built drawings, however there were several intermediate high points or humps in the pipe.

Two air pockets were discovered by the video camera from 245 ft to 262 ft and from 1223 ft to 1280 ft. The air pockets allowed for visual inspection of the pipe. These air pockets correspond to upward sags shown on the profiles located in Figure 2.

After reviewing the location of the heavy debris from 5 ft to 130 ft in the pipeline, it was determined that the heavy debris is downstream of the first intermediate high point and in the steepest section of the pipeline. The debris was likely caused by the flushing activities which pushed accumulated sediments and solids to near the discharge point of the pipe. However, these materials and solids were too heavy to be pushed through the pipe because of the low velocity used for flushing.

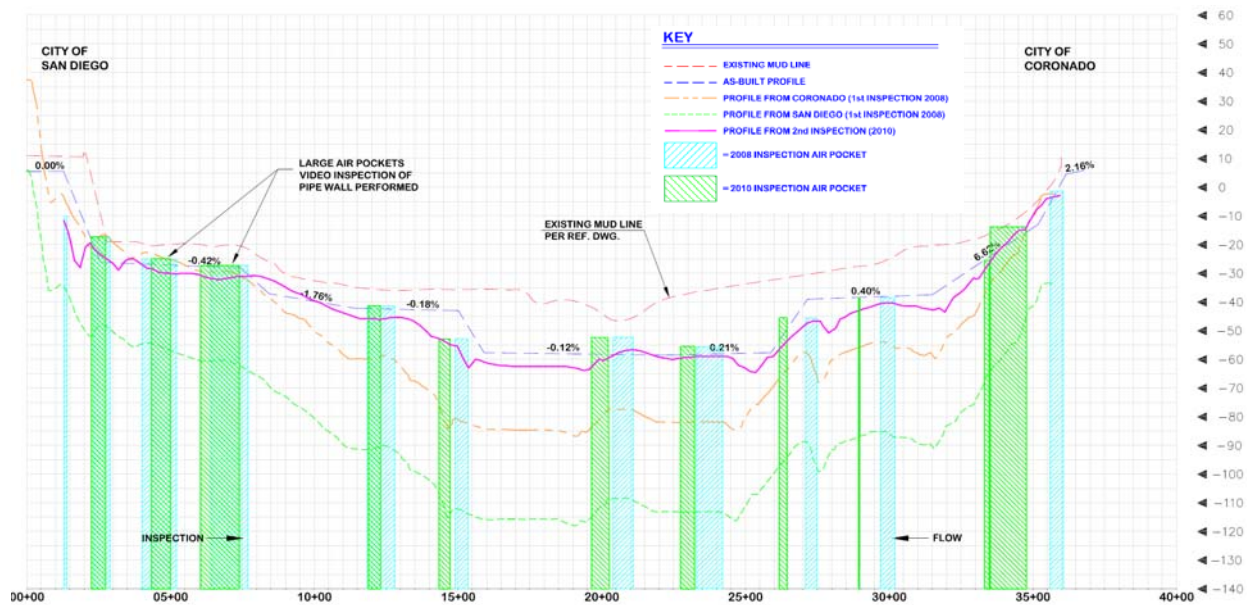
Figure 5: Profile of Original Force Main using As-Built Data and Camera Data from 2010 Inspection

In addition, the length of the pipeline was found to be approximately 3,500 LF. With the improved inclinometer, the profile of the pipeline could be better mapped as shown in Figure 3. The profile was created using the same techniques from 2008. Instantaneous slope values from the inclinometer were used to plot the approximate profile of the pipeline. The profile calculated more closely matches the profile from the as-built drawings.

The continuous sonar produced quality data that does not indicate any detectable structural defects in the pipeline. This is further evidenced by the air pockets; air would escape if there were cracks or openings in the pipe. The crawler was able to detect 10 intermediate high points in the pipeline where air pockets have formed as compared to the 11 air pockets found in the 2008 inspection. The air pockets provided a clear visual inspection of the force main interior. In those areas no visible signs of corrosion were detected.

The exact linear distances of the air pockets from the manhole differs from 2008 but is attributed to the new winch and more accurate software. Based on these results, the inspection team concluded that original force main appeared to be similar condition over the two year period and was reasonable to extend the inspection period to a three year period.
