The Northern California Pipe User's Group
18th Annual Sharing Technologies Seminar

FRP Repair of Mile-Long Pipeline with Minimum Downtime

Mo Ehsani, Ph.D., P.E., S.E.¹, and Carlos Peña, M.S., P.E.²

ABSTRACT: This paper describes the repair of a cast-in-place reinforced concrete pipe at the El Encanto power plant outside San José, Costa Rica. The pipeline is 5,742 ft (1750 m) long with a diameter of 7 ft (2.1 m) brings water from an upstream reservoir along a mountainous terrain to the plant. While the water in the pipe is not pressurized, the change in elevation from the reservoir to the turbine complex introduces some pressure in the pipe.

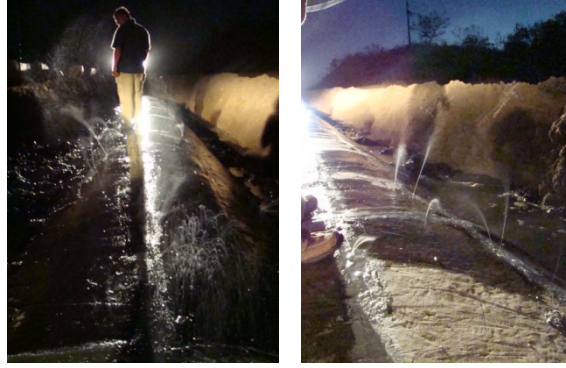
The pipeline was drained and all visible cracks were sealed using typical repair materials available locally. When the pipeline was pressurized again, the repaired cracks again leaked. The leaking at the repaired cracks was most likely due to the increase in the crack width due to the deformations of the pipeline caused by the increase in internal pressure. Given the rigidity of most crack sealing materials, full deformation compatibility between the repair material and concrete could not be achieved, degrading the seal and allowing leaks to reoccur. Figure 2 illustrates typical leaks occurring at two locations along the length of the pipeline during tests conducted at maximum operational pressure.

Figure 2: Leaking after conventional crack sealing

An FRP lining consisting of one layer of bidirectional glass fabric was designed to provide a humidity barrier, to provide an effective crack control mechanism, and to provide additional hoop strength to account for a significant loss of hoop steel due to corrosion. Since in all likelihood the corrosion process at the reinforcing steel had already started due to the two-way humidity paths occasioned by the existing cracks, the additional hoop strength provided by the FRP effectively increased the useful life of the pipeline. It should be noted that the humidity barrier is effective against water leaking into and out of the pipe, due to seepage or internal pressure effects, respectively; however, the corrosion of the steel reinforcement will not be slowed significantly as a result of the humidity barrier, since seepage water will continue to provide the means for this process to continue. While nonstructural linings can also provide two way humidity barriers, nonstructural linings cannot account for the loss of structural integrity caused by the ongoing corrosion due to the presence of seepage water.

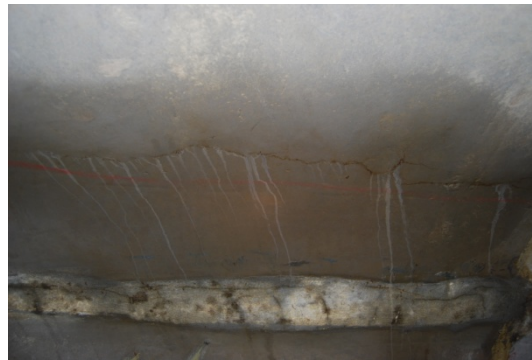
Moreover, the cracks generated multiple paths for humidity intrusion that reached the steel reinforcement of the pipeline, allowing for corrosion problems that, if not properly addressed, could compromise the structural integrity of the pipeline in the future. Complicating the problem even further was the combination of mountainous topography and the constant tropical rains. Since most of the pipeline is buried underground, water draining down the mountains keeps the surrounding soil constantly saturated and generates seepage pressures. In fact, with the pipeline empty, seepage water was observed draining through some of the longitudinal cracks (see Figure 3).

Figure 3: Seepage water draining into pipeline

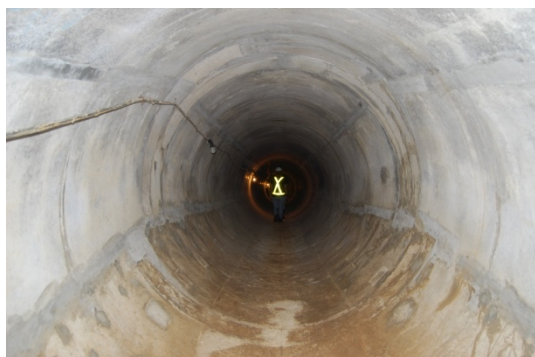
The application of FRP linings requires a certain amount of preliminary work to the pipe surface in order to maximize contact and bond strength between the substrate and the FRP. Therefore, pressure washing, as well as some patching and/or grinding must take place in the areas targeted for lining with FRP. In the case of the El Encanto pipeline, the amount of preliminary work was atypically large, since the cast in place construction process caused significantly more surface irregularities than those associated with the more traditional precast pipes, such as Prestressed Concrete Cylinder Pipe (PCCP). Figure 4 shows the typical condition of the interior surface of the pipeline prior to initiating prep work activities. Evidence of

cast in place procedures can be observed, such as construction joints, formwork fins, etc. The pipeline was pressure washed with 7,000 psi machines to remove any scour, sediment, curing compounds, or any other substance that could hinder the bond between the FRP and the pipe surface. Figure 5 shows grinding of protrusions on the interior surface of the pipeline.

Figure 4: Initial interior surface conditions of the pipeline

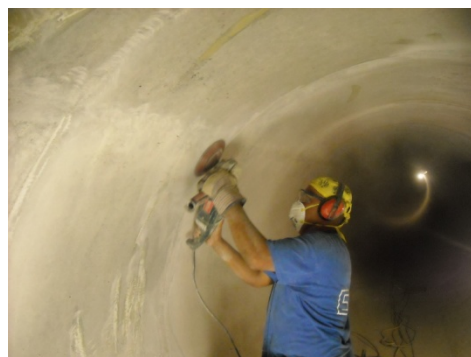
Figure 5: Prep work activities prior to installing FRP lining

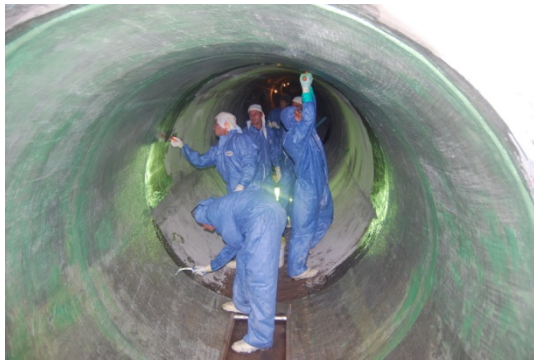
Figure 7(a) Epoxy paste installation on top half of pipeline

Figure 7a illustrates the application of an epoxy paste to the top half of the pipeline; the main purpose of the paste is to prevent peeling due to the weight of the saturated FRP fabric, and to seal the surface to prevent excessive absorption by the dry concrete surface of the epoxy resin from the saturated FRP fabric. Figure 7b shows the installation of the first roll of FRP lining material at one of the installation stations. The access point is clearly visible on the lower left portion of the figure. Figure 7c shows the transition between the top and bottom half installation. Notice that there is no epoxy paste used in the lower half. Since gravity effects in this area tend to hold the FRP fabric in place, only a seal coat of epoxy resin was used to prevent excessive absorption from the saturated fabric. Figure 7d illustrates overlap and fabric edge detailing. Detailing is done with epoxy paste and/or epoxy resin to feather down edge fibers, and to secure in place the overlaps in the lining.

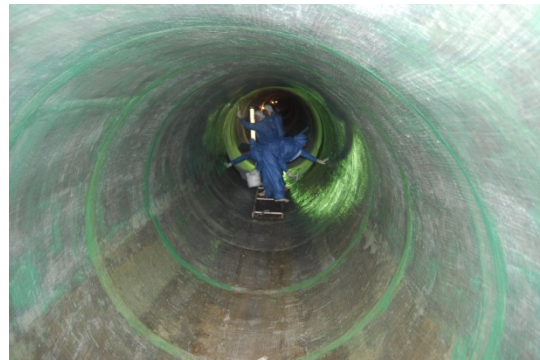
Figure 7(b) Installation of FRP lining

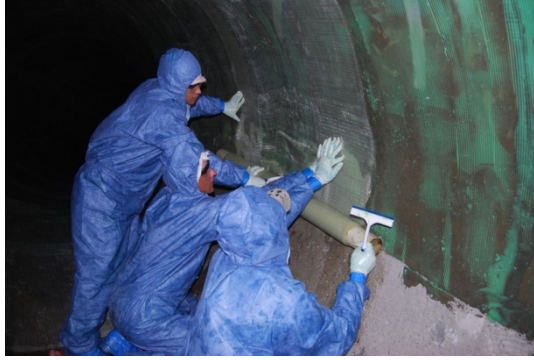
Figure 7(c) Transition between top and bottom half installation

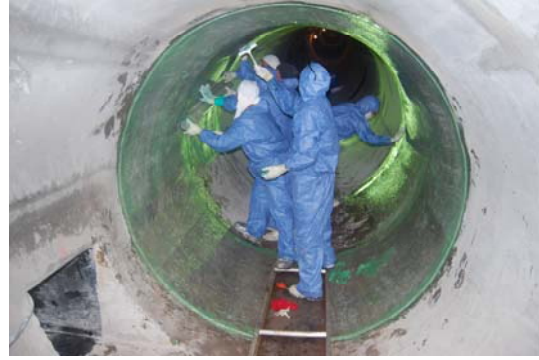
Figure 7(d) Detailing of lining installation

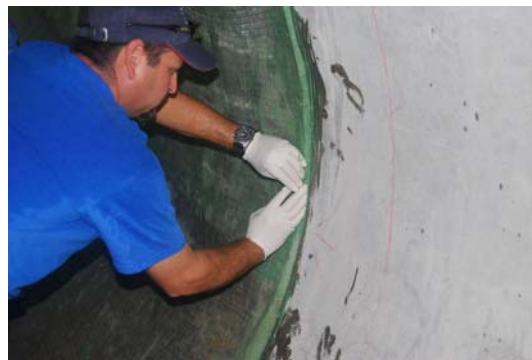
Figure 8: Construction joint of FRP lining

Specially designed construction joints (see Figure 8) were prepared at the starting point of each installation run, which also became the end points of the installation front that started at a downstream access point. The joint was later sealed with an epoxy paste. Nowhere in the 5,742 ft length of the pipeline were FRP lining edges left exposed to peeling from water flow, maximizing the water tightness of the installation.

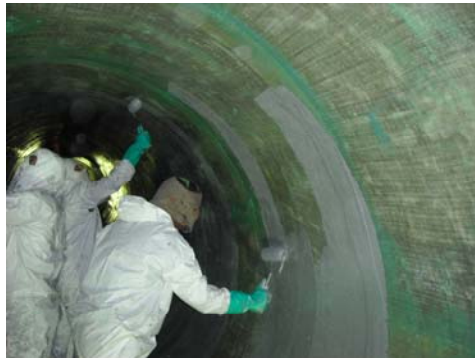
Figure 9: Application of epoxy top coat

Finally, an epoxy top coat was applied as a cover for all the installed FRP. This coat provides resistance to the abrasion caused by sediment carried by the river water, and additional leak proofing by covering any pin holes remaining in the FRP lining. The coating has a concrete gray color, which facilitates quality control by providing a visual means of verifying that the entire light green-colored FRP lining is fully covered, and that any uncovered spots can be easily detected.

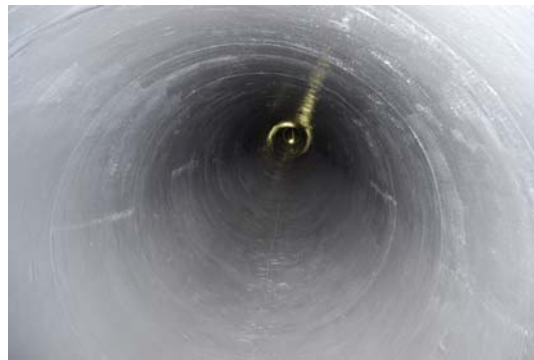
Figure 10: Completed segment of the FRP installation

The FRP lining installation was completed on July 8th, 2009, and pressurized test runs were successfully completed. Figure 10 shows a completed lining installation prior to testing.
