The Northern California Pipe User's Group
19th Annual Sharing Technologies Seminar

Berkeley, CA
February 17, 2011

**THE LOST ASSETS: PROTECTING SEWER CREEK CROSSINGS AND THE ENVIRONMENT
THE CREEK PROTECTION PROJECT, SACRAMENTO AREA SEWER DISTRICT
SACRAMENTO, CALIFORNIA**

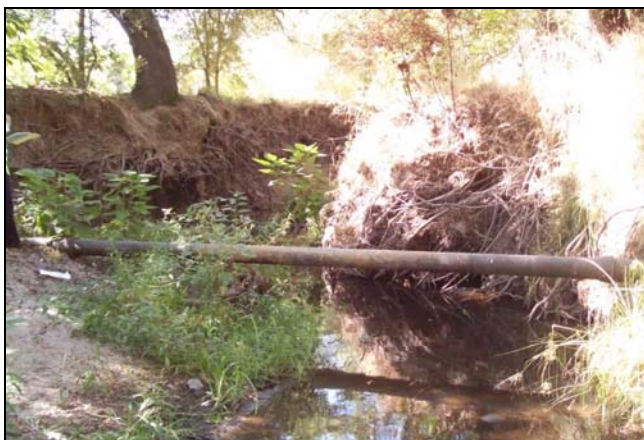
Photo 1 – Site 13 consists of a cast iron pipe that was originally buried and was exposed as the creek incised over time.

Site 13 consists of a 6-inch diameter CIP gravity pipeline located in Arcade Creek. As-built drawings indicate the sewer line was originally buried with essentially no cover at the creek flow line. The crossing is now completely exposed and unsupported for 23 linear feet. The pipeline is three feet above the creek bed with two exposed joints.

Due to the significant erosion occurring, exposed pipeline, and unsupported joints, the following repairs will be performed at Site 13:

- Installation of approximately 715-ft of new pipeline re-routed away from the creek.
- Removal of the existing aerial creek crossing.

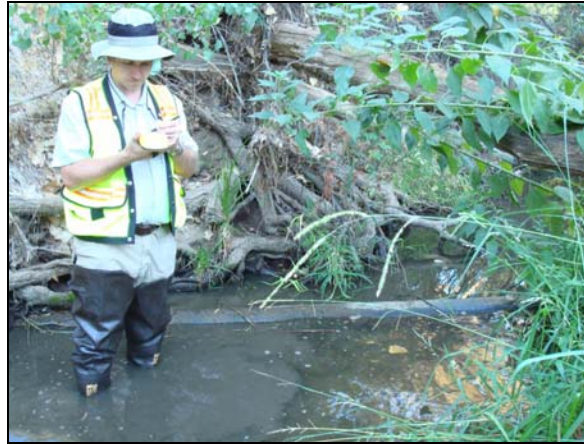
Photo 2 – Rapid geomorphic assessment was used to characterize the overall geomorphology at each of the creek crossing sites.

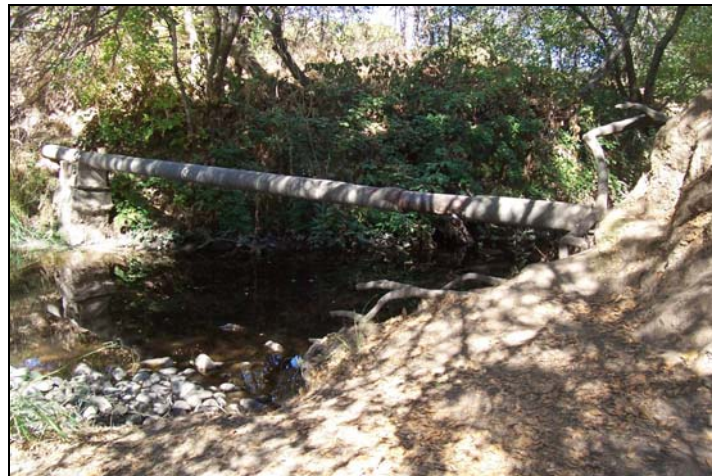
Photo 3 – A structural engineer performed field visits to sites where potential structural deficiencies were identified during the initial field visit.
