The Northern California Pipe User's Group
18th Annual Sharing Technologies Seminar

FRP Repair of Mile-Long Pipeline with Minimum Downtime

Mo Ehsani, Ph.D., P.E., S.E.¹, and Carlos Peña, M.S., P.E.²

ABSTRACT: This paper describes the repair of a cast-in-place reinforced concrete pipe at the El Encanto power plant outside San José, Costa Rica. The pipeline is 5,742 ft (1750 m) long with a diameter of 7 ft (2.1 m) brings water from an upstream reservoir along a mountainous terrain to the plant. While the water in the pipe is not pressurized, the change in elevation from the reservoir to the turbine complex introduces some pressure in the pipe.

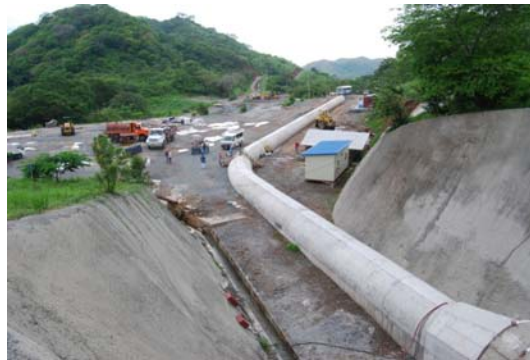
Figure 1: Above ground segment of the “El Encanto” pipeline

Although the structural design properly addressed the strength requirements of the pipeline and accounts for the design pressure and hydrodynamic loads, the pipeline’s serviceability requirements were overlooked in the structural design. The pipeline exhibited significant longitudinal cracking during a pressurized test and as a result, as much as 20% of the flow was lost due to leaks.

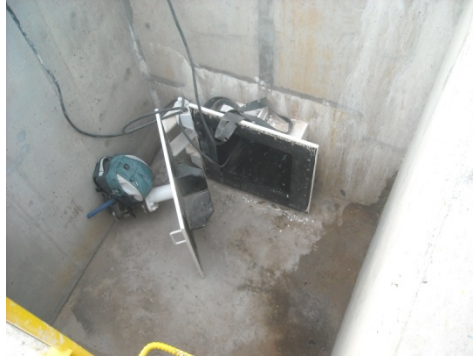
The 5,742 ft long pipeline had four lateral access points at the locations of relief valves, with spacing ranging from 1,000 ft to 1,500 ft. These 24" x 24" access points (see Figure 6) were used to supply FRP materials, tools and equipment to four installation stations inside the pipeline.

Figure 6: Typical access point
