The Northern California Pipe User's Group
19th Annual Sharing Technologies Seminar

Berkeley, CA
February 17, 2011

HDD Successfully Completes Ocean Outfall Project

Glenn Duyvestyn, Ph.D., P.E.
Hatch Mott MacDonald, Inc., Cleveland, OH

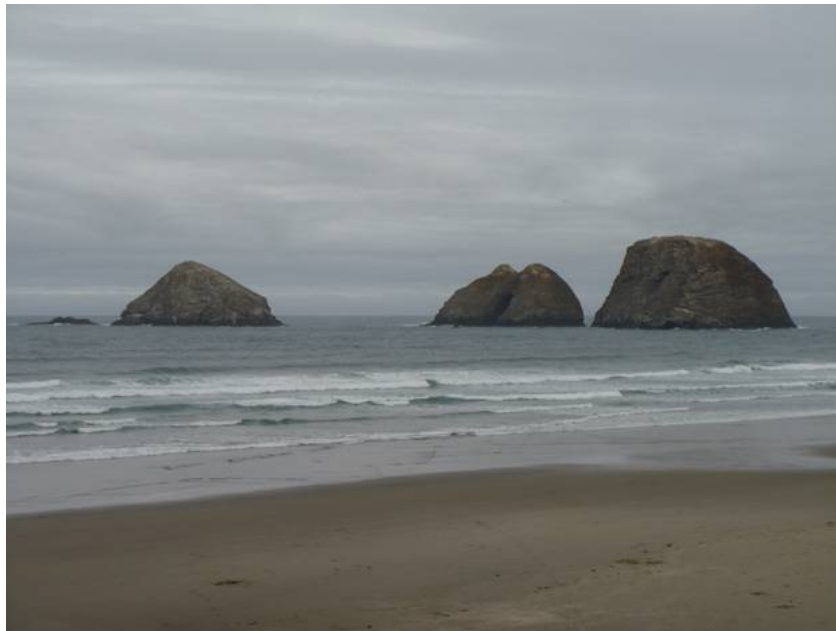
Figure 2. Photograph of exposed Grande Ronde Basalt Outcrops north of the project site

20 feet in the near shore portion of the survey to approximately 63 feet near the end of the existing outfall. Seismic velocities obtained during surveying indicated the presence of sandstone, siltstone and/or mudstone below the surveyed locations. Diving surveys of submerged exposed bedrock materials on the ocean floor identified the bedrock as basalt. These exposed outcrops are similar to the basalt outcrops that project above the sea level north of the project site (Figure 2).

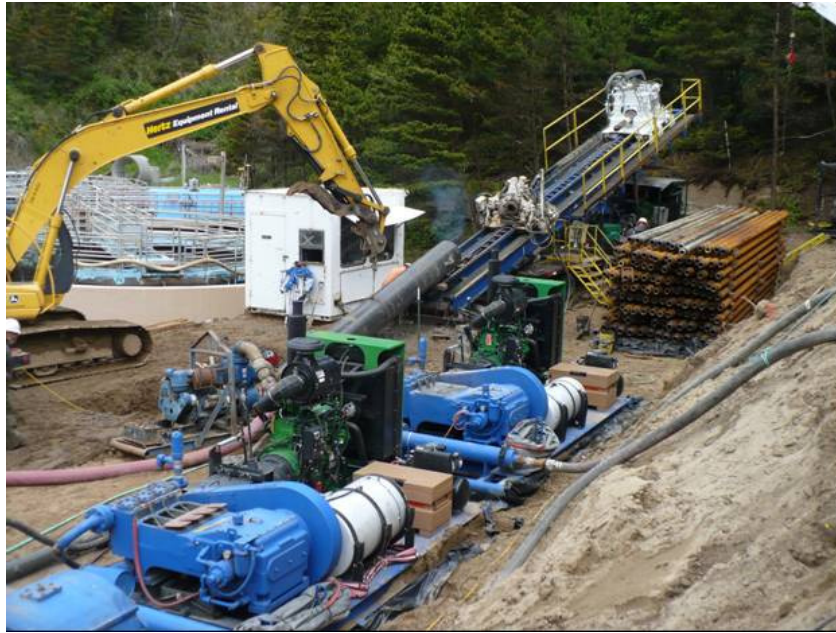
Figure 3. Photograph of staging area next to existing wastewater treatment plant.

- **Small on-shore staging area.** The topography of the HDD entry location was very confined and required excavation and leveling to provide sufficient room to stage the required equipment (Figure 3).

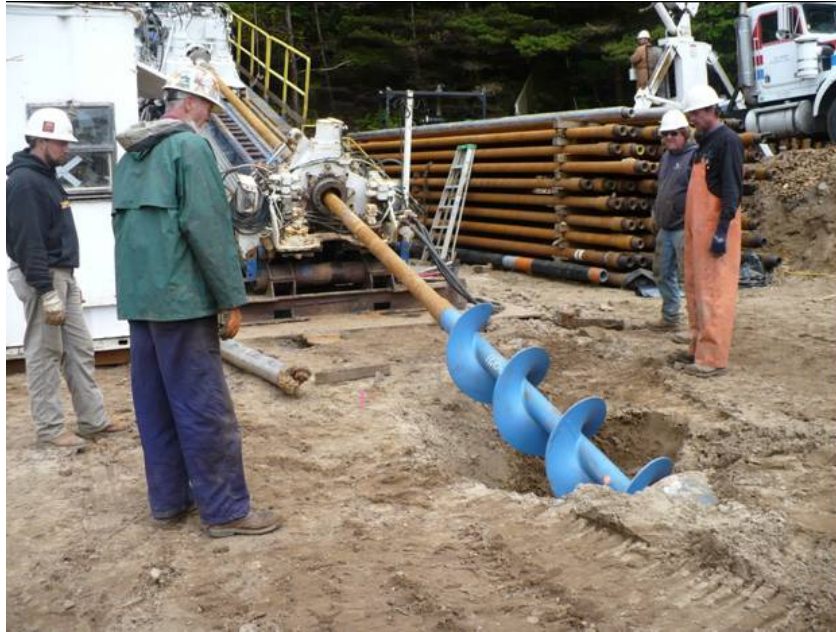
Figure 5. Photograph of auger flight used to remove spoil from inside conductor casing

- **Conductor casing installation issues.** The design required the installation of approximately 210 feet of conductor casing to support the fill materials and provide a pathway for the drilling fluids to return to the drill rig for reclamation and reuse. A pneumatic hammer was used to ram the steel 24-inch steel conductor pipe into the ground along the 18-degree HDD entry angle. As the casing pipe was rammed into the ground, frictional forces acting on the outside of the casing pipe and within the casing pipe limited progress to a rate of 6 to 8 minutes per foot. When the production rate slowed to this rate, the Contractor elected to cut the casing and cleanout the spoil within the casing pipe to reduce the frictional forces acting on the inside of the conductor casing. Cleaning was accomplished using the drill rig to advance a 12 foot long auger flight connected to the drill pipe (Figure 5). In total, approximately 202 feet of the conductor casing was installed in 7.5 days.

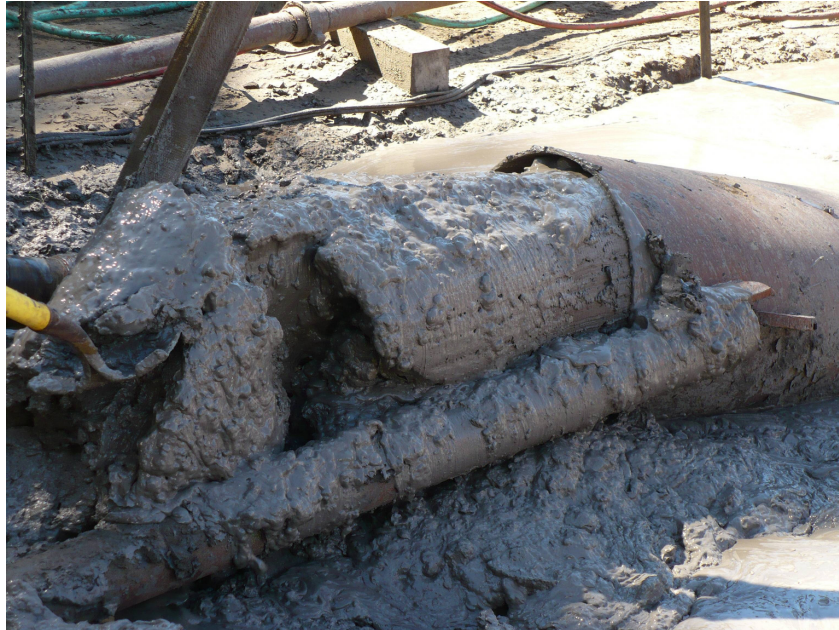
Figure 6. Photograph of clay slugs during reaming process

- **Maintaining fluid returns.** Maintaining drilling fluid returns during the reaming process proved to be difficult at times. While no frac outs or lost returns occurred, the drilling fluid returns would cease momentarily while clay slugs were pushed out of the bore approximately every 100 feet. The Contractor reacted to the stoppage in drilling fluid returns by pulling back and clearing any blockages within the bore with the reamer assembly. The clay slugs measured 24-inches in diameter and up to 30 feet in length (Figure 6). Once cleared, full drilling fluid returns were again received at the drill rig.

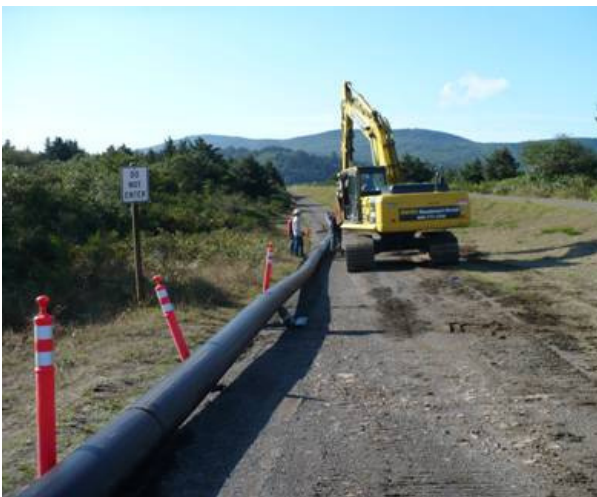
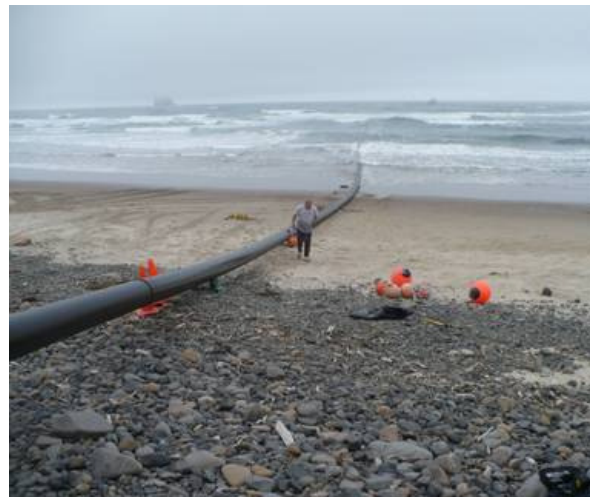
Figure 7. Photographs during product pipe transportation prior to installation

- **Product pipe fabrication.** The 14-inch DR 7.3 IPS HDPE product pipeline was fabricated along a limited access road along a spit between the Pacific Ocean and Tillamook Bay. Once fabricated, the entire 4,120-foot pipe string was moved approximately 4,500 feet down the road, across a 4,000 foot long fresh water lake and up onto the beach (Figure 7). From here, a tow line was attached to the HDPE pipe and taken off shore to a tug boat and the pipe string was towed to the HDD exit location.

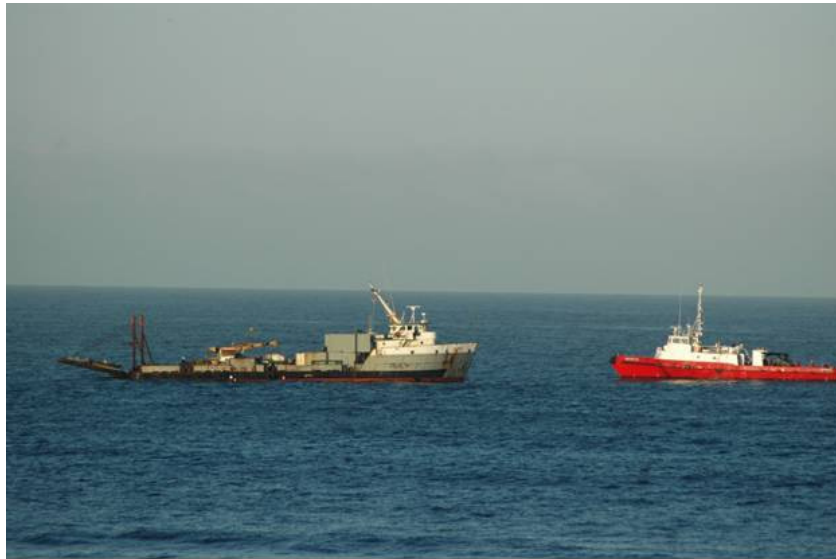
Figure 8. Photograph of the offshore work boats used to support HDD activities and construct the outfall diffuser

- **Connecting HDPE pipe string to the drill pipe.** Weather conditions and poor visibility on the ocean floor delayed attaching the HDPE pipe string to the drill pipe. To complicate matters, the divers misplaced the Contractor's swivel delaying the product pipe installation. During the time required to fabricate a new swivel, the HDPE product pipe was damaged at the back of the work boat used to support the exit site work activities. The damaged pipe required cutting and re-welding the pipe string together. In all, connecting the product pipe to the drill pipe string took six (6) days. A photograph of the work boat used to install the HDPE product pipe and to fabricate the diffuser structure is shown in Figure 8.

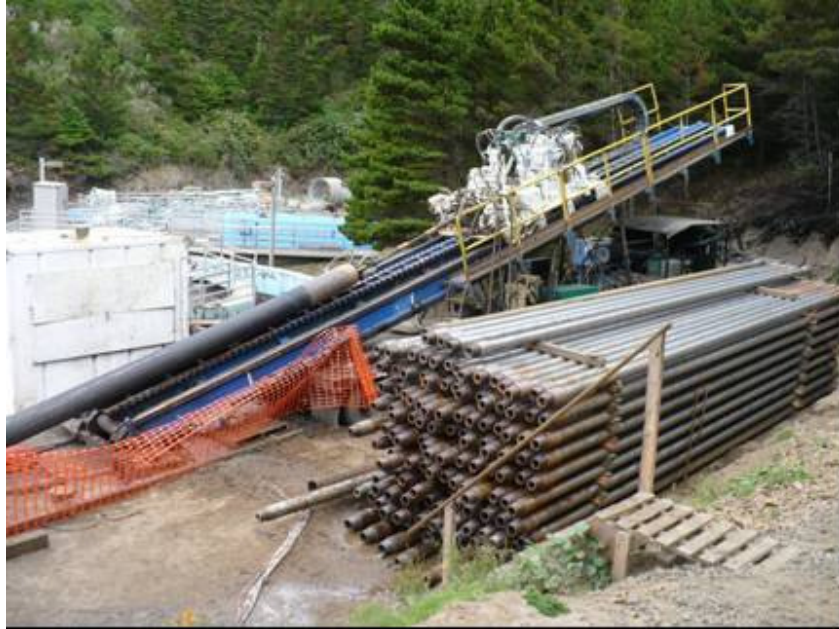
Figure 9. Photograph of completed installation of product pipe

- **Pipeline installation.** The product pipe installation commenced at 3:05 PM on Thursday, September 11th, 2008 and was completed at 2:30 AM Friday, September 12th, 2008 (Figure 9). During the initial 120 feet of the pullback process, the barrel reamer did stall in a similar manner as it did during the swab pass. The reamer was freed by pushing a few feet forward when it locked up. The majority of the drill pipes were pulled within 1 to 3 minutes each. The maximum installation load was approximately 65,000 lbs. Drilling fluid returns were observed at the drill rig with 575 feet remaining to be installed despite the 110-foot elevation difference between the HDD entry and exit locations. The occurrence of drilling fluid returns at this distance was predicted during the design phase of the project using the method described in Duyvestyn (2009).
